**NORFOLK Z-LOOP REPAIR
PROJECT COMPLETION REPORT**

**FPO-1-83(27)
AUGUST 1983**

This report describes the repairs to the Z-loop in Slip #2 at the Norfolk Deperming Facility, Naval Station, Norfolk, Virginia. The repair design and installation were the responsibility of the Ocean Engineering and Construction Project Office of the Chesapeake Division, Naval Facilities Engineering Command (CHESNAVFACENGCOM). The repairs were carried out by personnel of Underwater Construction Team One (UCT-ONE).

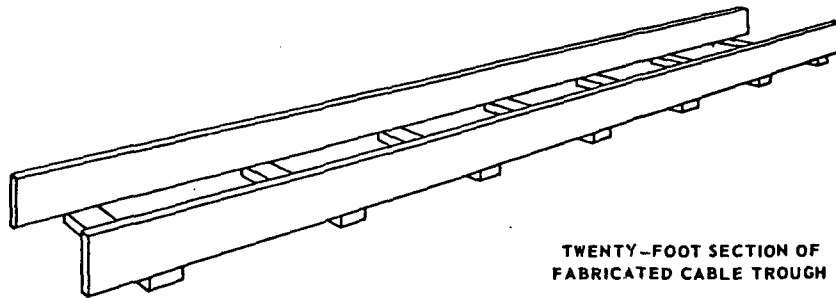
FIGURE 3-1

TWENTY-FOOT SECTION OF
FABRICATED CABLE TROUGH

The conduits are housed in and supported by troughs of pressure-treated wood bolted to existing pier cross braces at about 28 feet below the MLW. The troughs are similar to those supporting the existing Z-loop, except that bolts instead of nailed fasteners are used. After installation, the conduits are secured to the troughs by nylon straps. A typical trough section is shown in Figure 3-1 and views of the risers from trough to catwalk are shown in Figure 3-2.

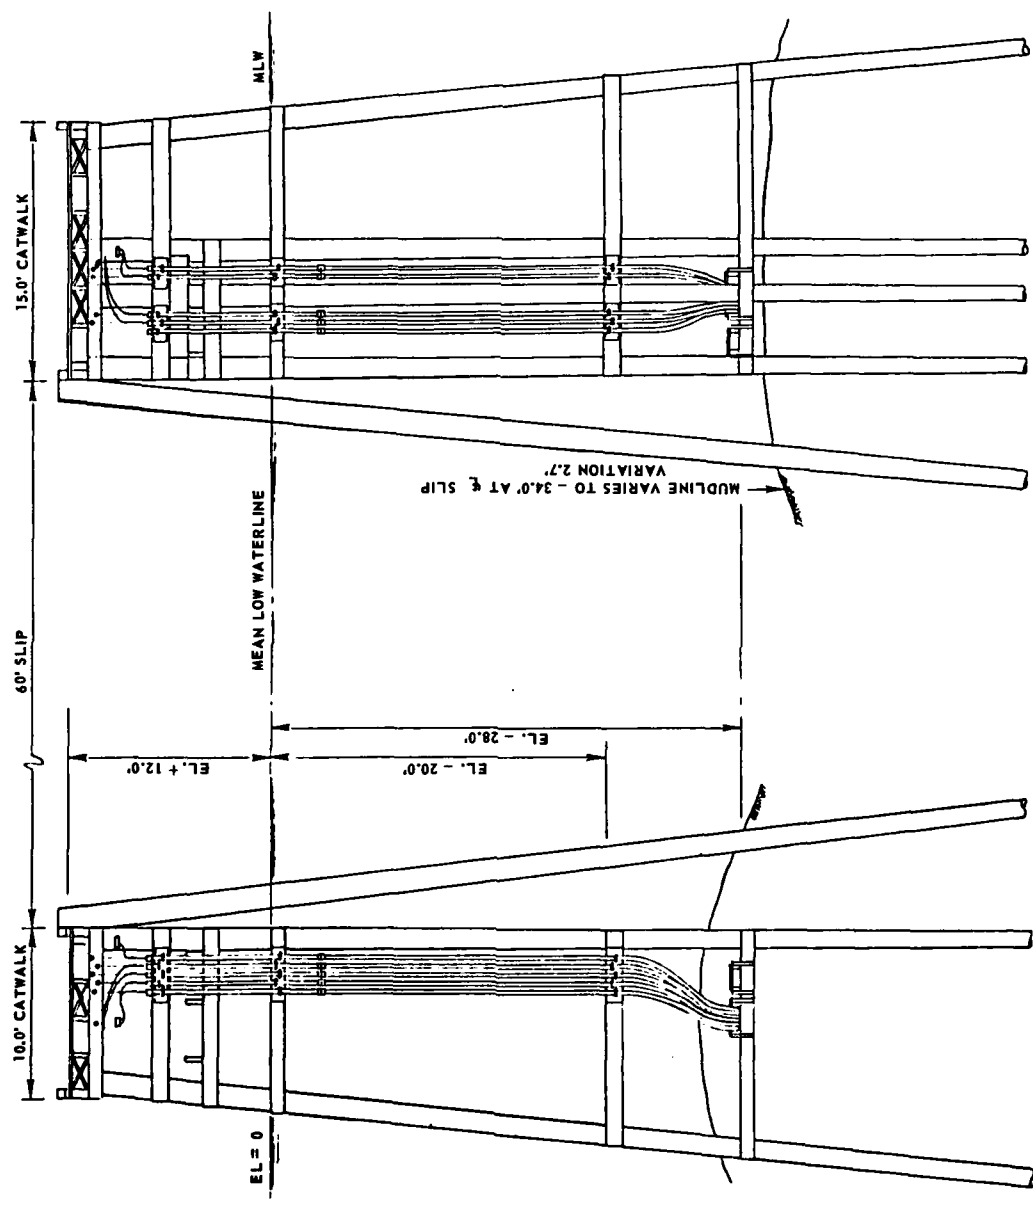
FIGURE 3-2

RISER TUBES AT ENDS OF CATWALKS/BENTS 31 AND 62 SHOWN LOOKING NORTH

The final design, as shown in the drawings of Appendix B, called for individual conduits for the nine replacement cable lengths together with eleven empty conduit sections to be used for future cables. At a point a few feet below the mean low waterline (MLW), the flexible conduit was connected to rigid PVC conduit, which was secured to retaining clamps attached to existing cross members on the pier.

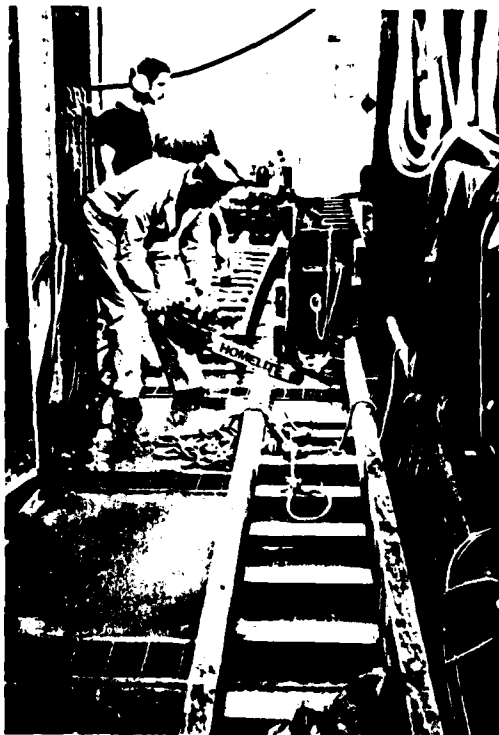
FIGURE 4-8

FABRICATING CABLE TROUGH
FROM 3 x 8 SIDE MEMBERS
AND 2 x 6 CROSS MEMBERS.
END CUT TO LENGTH MEASURED
BY DIVERS TO FIT BETWEEN
PIER BENTS.

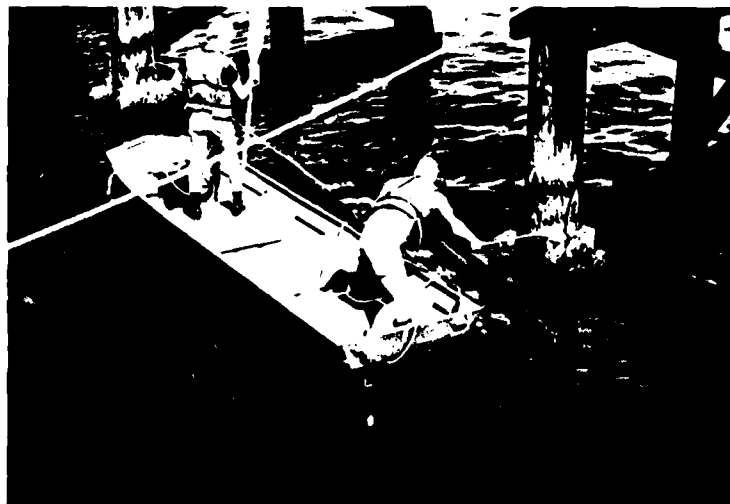
FIGURE 4-9

FLOATING FABRICATED TROUGH BETWEEN PIER BENTS

After several trough sections had been installed, Figure 4-9, a routine was developed. A number of sections were fabricated and stacked on the deck of the barge. A section was cut to length and the angle iron mounting brackets and lag bolts were lashed to it. The trough section was manhandled into the water and floated into position between the pier bents. Because the trough section was longer than the space between cross-braces on the bents, it was necessary to insert it at an angle. Men working from a boat or from a catwalk under the pier (where one was present) attached descent lines and installed weights in the trough section to sink it. Divers, who had been waiting on the surface at the two adjacent bents, followed the trough as it was lowered and guided it into place. The diver at one end then bolted the angle brackets to the trough and to the pier cross-brace, using a hydraulic impact wrench and lag bolts. After one end was secured, the divers used a steel tape and a flashlight to determine the cutting length for the next trough section; this information was relayed to the surface. The divers then secured the remaining end of the trough, attached the weight to the descent lines for retrieval, and returned to the surface to wait for the next trough section.
